# Examination of BSU-86/B Setscrews

ARL-MR-379

NOVEMBER 1997

Marc S. Pepi  
Weapons & Materials Research Directorate

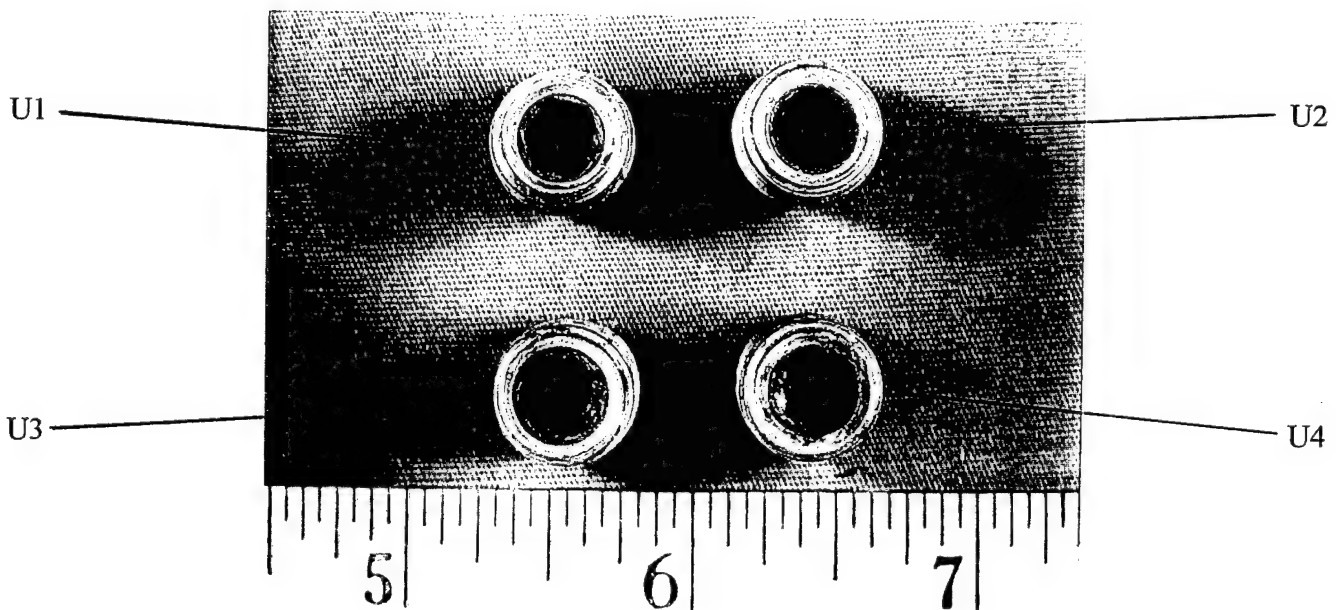
Figure 1. Photograph of the Four Used Setscrews in the As-Received Condition. (U1 represents the setscrew with the most intact socket, while U4 represents the setscrew with the worst stripped socket.)

The presence of any total decarburization is unacceptable, and measures should be taken by the manufacturer to alleviate this problem. Also, a square socket setscrew, rather than the hex-shaped socket, may provide a greater tolerance to stripping because of its geometry. In addition, care should be taken to ensure that worn tools are discarded, so as to reduce the chance of socket stripping. Also, automatic tools should only be used once the tool is engaged; a rotating bit placed into the socket increases the chances of stripping. Specified torque requirements should be obeyed. Automatic tools can be difficult to control and quite often result in over-torquing, which causes stripping of the socket.

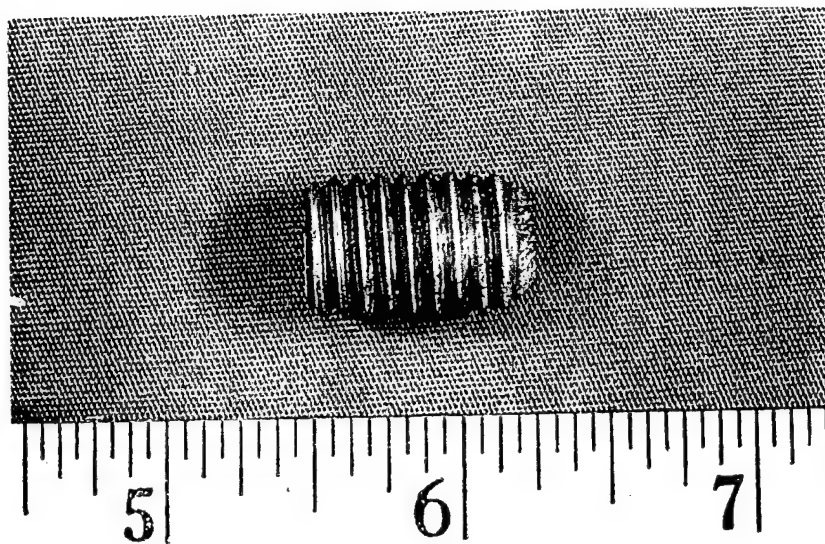
Figure 2. Representative Used Setscrew in the As-Received Condition.

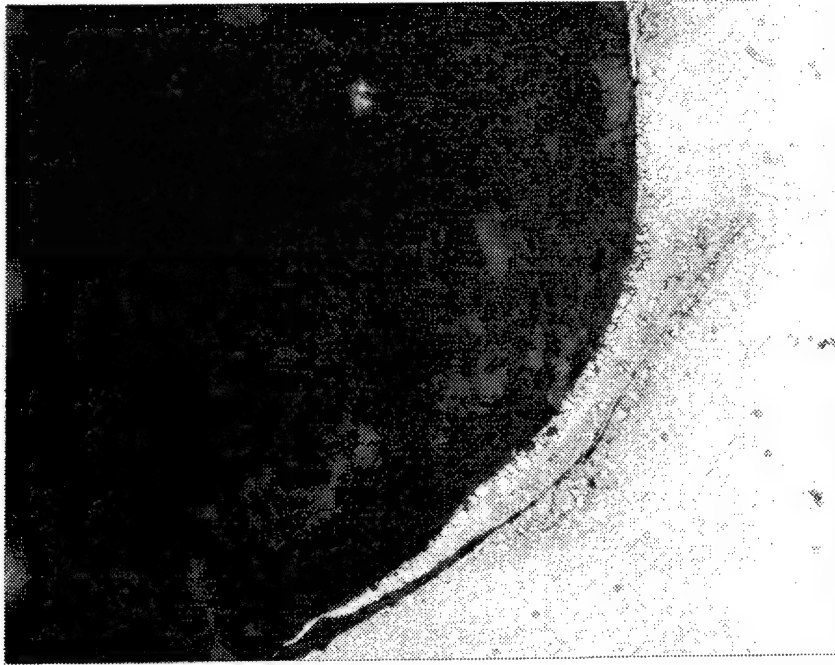
Metallography was used to confirm the presence of decarburization along the periphery of the setscrews. The setscrews that were sectioned and mounted for microhardness testing were subsequently metallographically prepared. The samples were first examined in the as-polished condition. The samples were relatively clean and exhibited no appreciable inherent material defects. Some surface laps were noted in the roots of some threads, as shown in Figure 6. This particular lap was found in a thread root of setscrew N1. Along the surface of the samples, areas of microcracking were also noted. These cracks were filled with cadmium, which indicated that they were present before the plating operation. The amount of cracking varied from setscrew to setscrew, as well as from thread root to thread tip. This cracking was not noted along the socket surfaces. The cracking along a thread flank of the U1 setscrew is shown in Figure 7, which represented the worst case

Figure 6. Lap Located Within a Root of Setscrew N1 (magnification 300x).

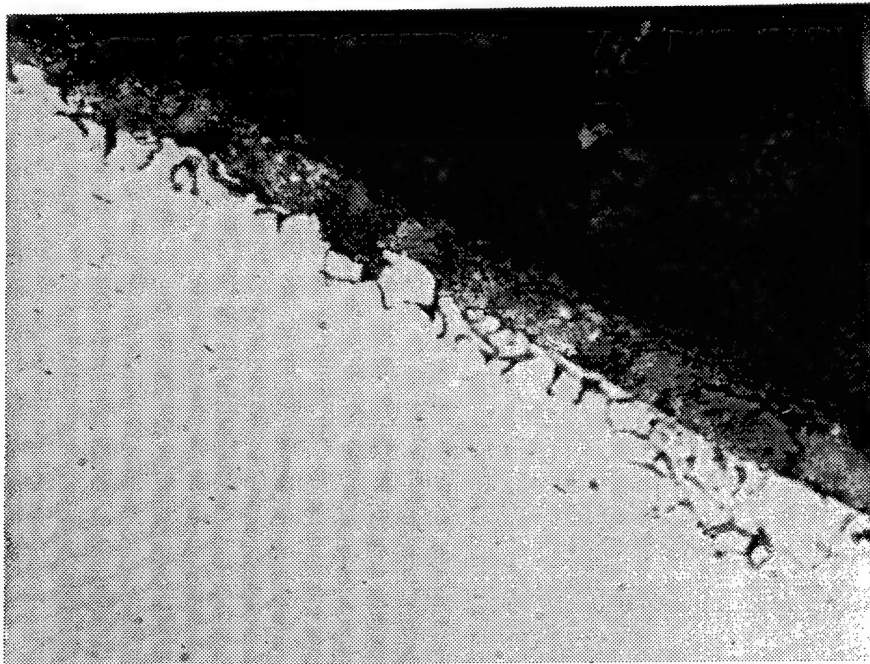
scenario. This cracking was heavier than that noted along the flank of the U4 setscrew (see Figure 8). Table 5 summarizes the extent of the cracking noted. No comparison could be drawn between the used versus the new setscrews; however, the heaviest areas of microcracking correlated to the regions of heaviest decarburization.

Figure 7. Microcracking Noted Along a Thread Flank of Setscrew U1 (magnification 1000x).

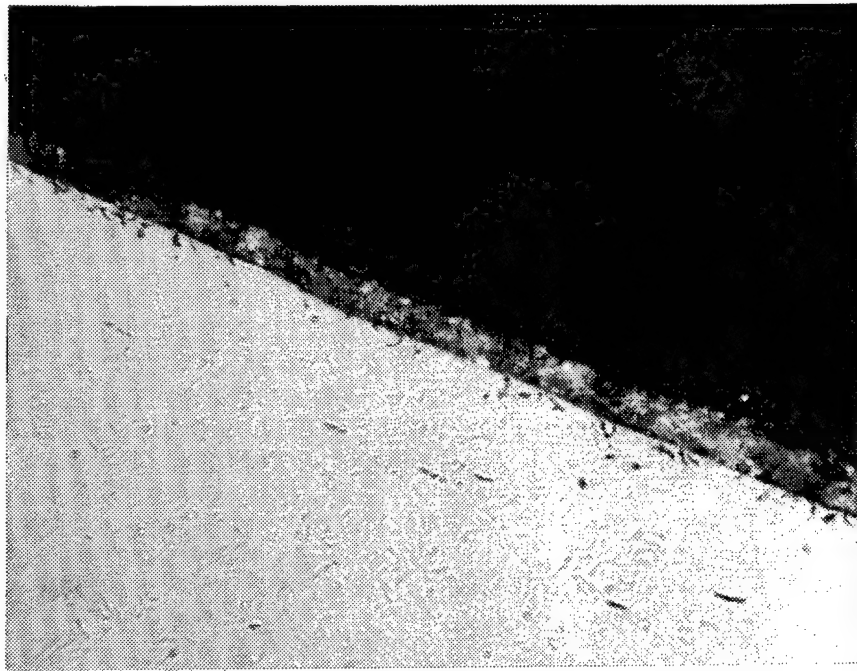
Figure 8. Microcracking Noted Along a Thread Flank of Setscrew U4 (magnification 1000x).

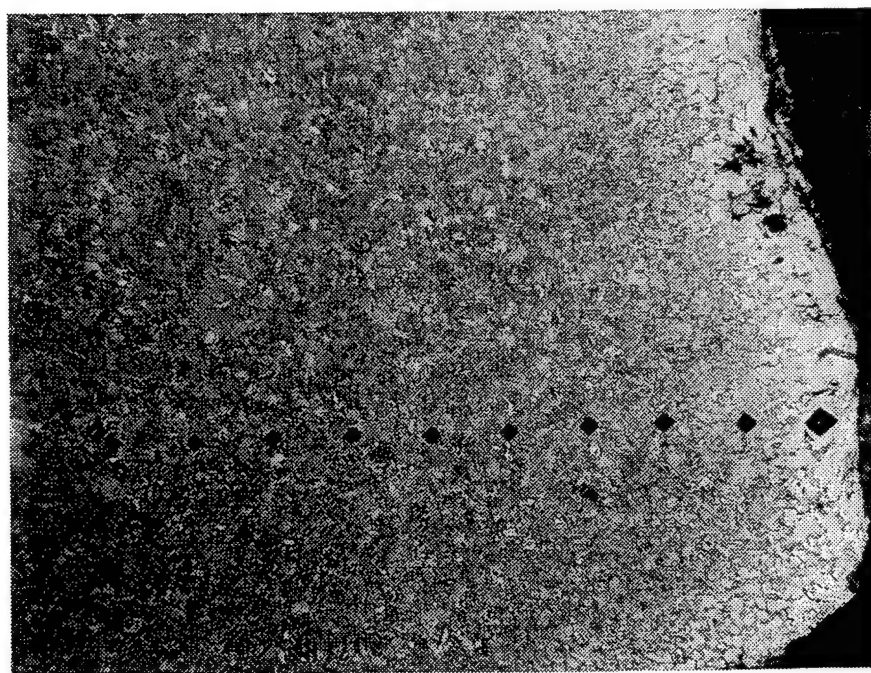
Figures 9 through 12 show the Vickers microhardness profiles taken from the thread tips of U1, U4, N1, and N2, respectively. Note that the setscrews with the heaviest amount of cracking (see Table 5) also exhibited the lowest surface hardness (see microhardness results) and the heaviest amount of surface decarburization (see Figures 9 and 12). Figure 13 shows a magnified view of the hardness indents at the tip of the thread of U1. Note that the indent located within the decarburized layer (white layer) is larger than the other indents. This shows that the decarburized layer is much softer than the transition zone and core. Figure 14 shows the decarburized layer at the thread tip of N2. Figures 15 through 18 show the hardness indents at surface of the socket for U1, U4, N1, and N2, respectively. Note the decarburization on U1 (see Figure 15) and N2 (see Figure 18).

Figure 9. Vickers Microhardness Profile Along the Tip of a Thread From Setscrew U1. (Note the layer of decarburization along the tip of the thread; magnification 200x.)

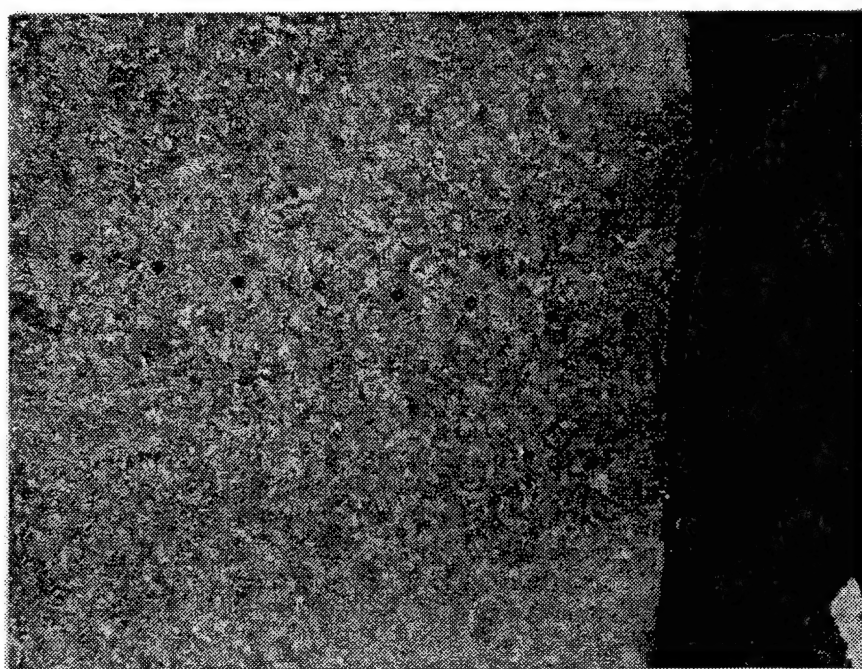
Figure 10. Vickers Microhardness Profile Along the Tip of a Thread From Setscrew U4 (magnification 200x).

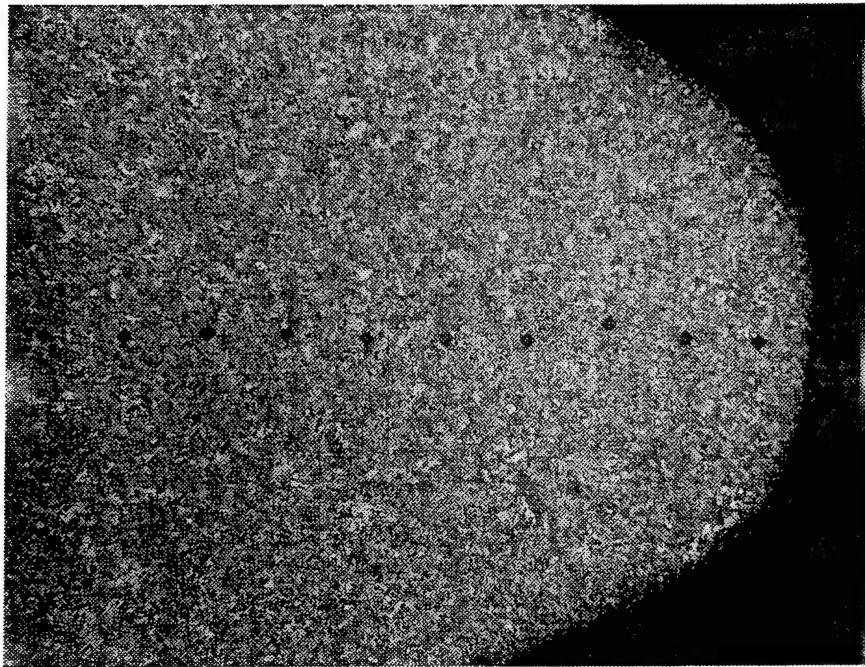
Figure 11. Vickers Microhardness Profile Along the Tip of a Thread From Setscrew N1 (magnification 200x).

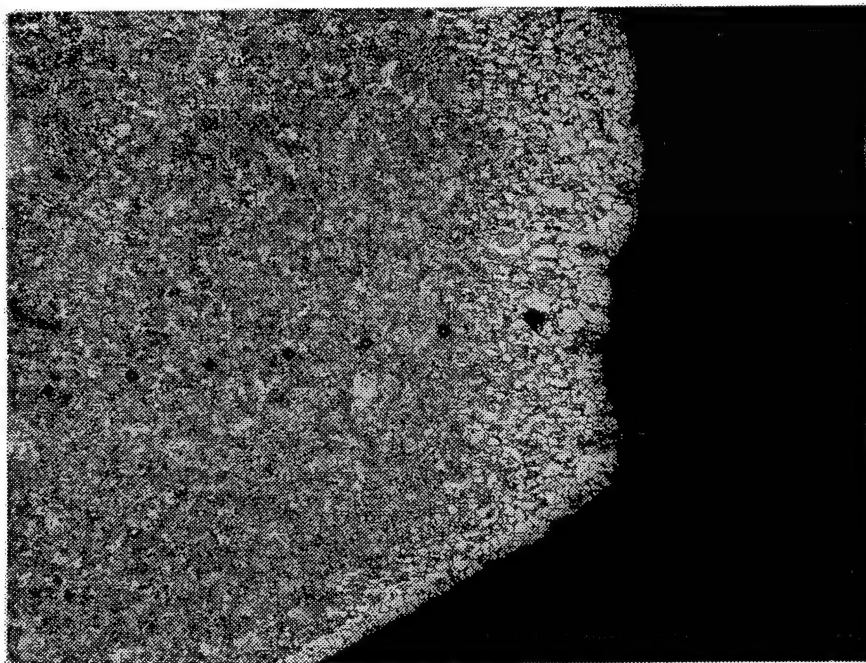
Figure 12. Vickers Microhardness Profile Along the Tip of a Thread From Setscrew N2. (Note the layer of decarburization along the tip of the thread; magnification 200x.)

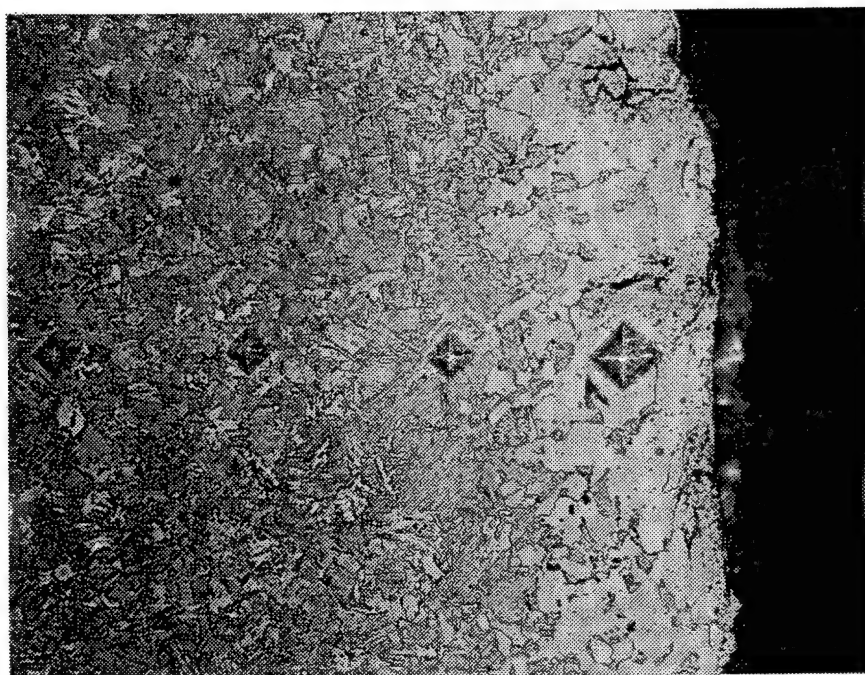
Figure 13. Vickers Microhardness Profile Along the Tip of a Thread From Setscrew U1 at Higher Magnification. (Note the larger indent within the decarburized layer indicating a softer material; magnification 500x.)

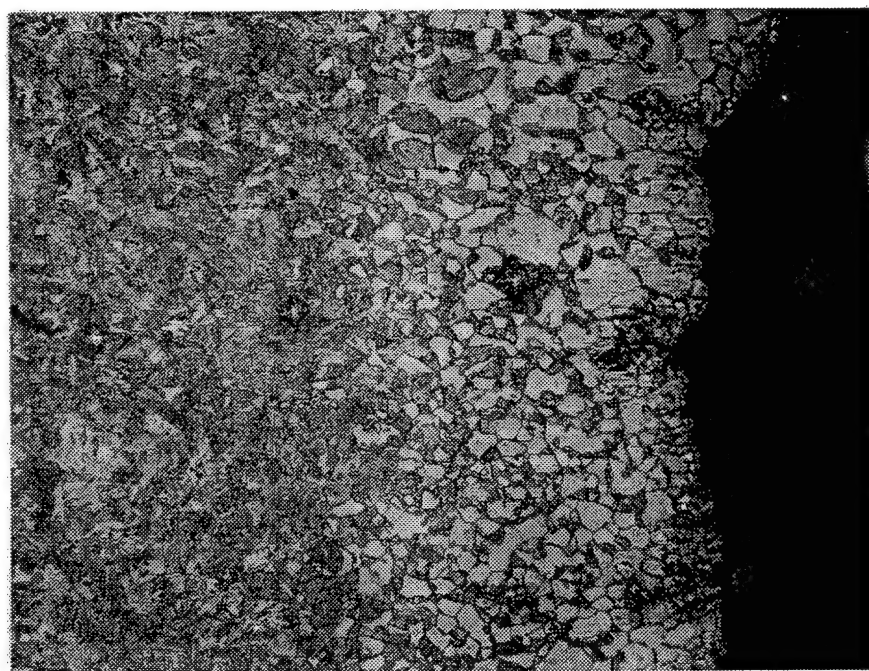
Figure 14. Vickers Microhardness Profile Along the Tip of a Thread From Setscrew N2 at Higher Magnification. (Note the larger indent within the decarburized layer indicating a softer material; magnification 500x.)

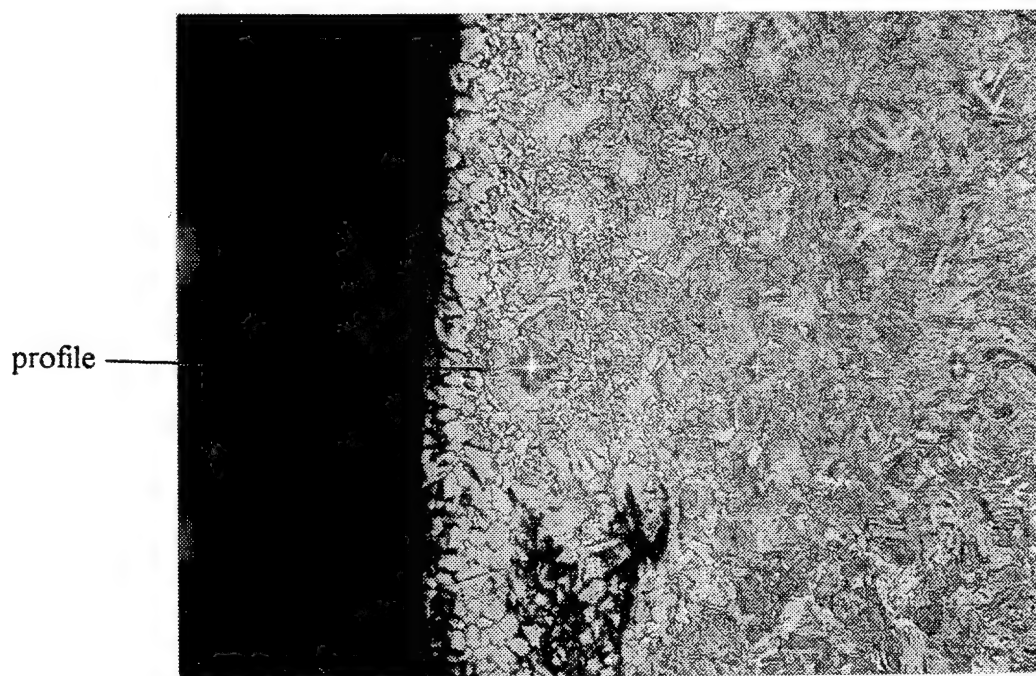
Figure 15. Vickers Microhardness Profile Along the Socket of Setscrew U1. (Note the larger indent within the decarburized layer indicating a softer material; magnification 500x.)

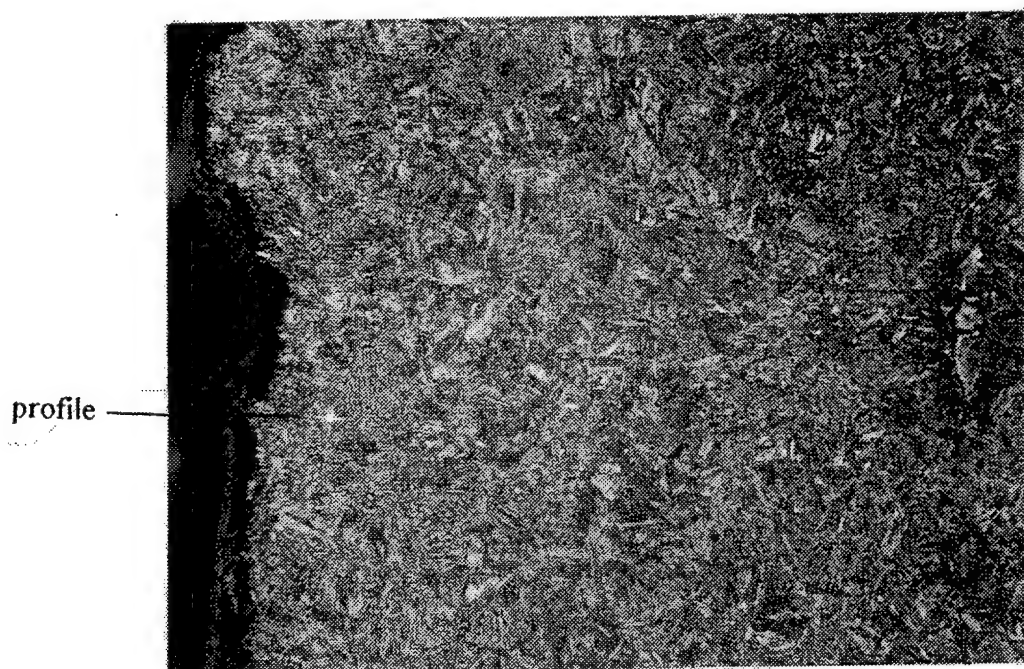
Figure 16. Vickers Microhardness Profile Along the Socket of Setscrew U4. (No decarburization was present on the socket surface; magnification 500x.)

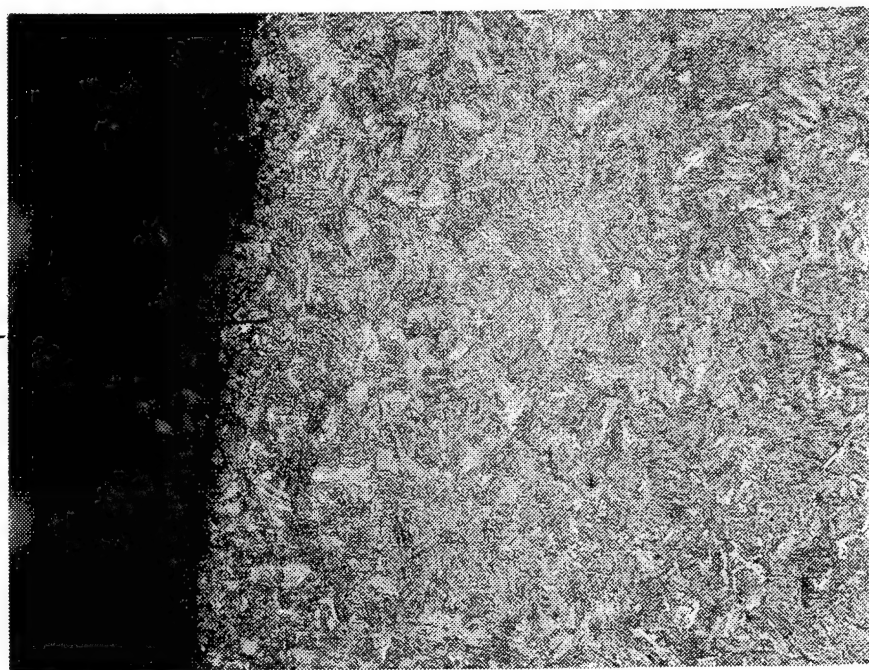
Figure 17. Vickers Microhardness Profile Along the Socket of Setscrew N1. (No decarburization was present on the socket surface; magnification 500x.)

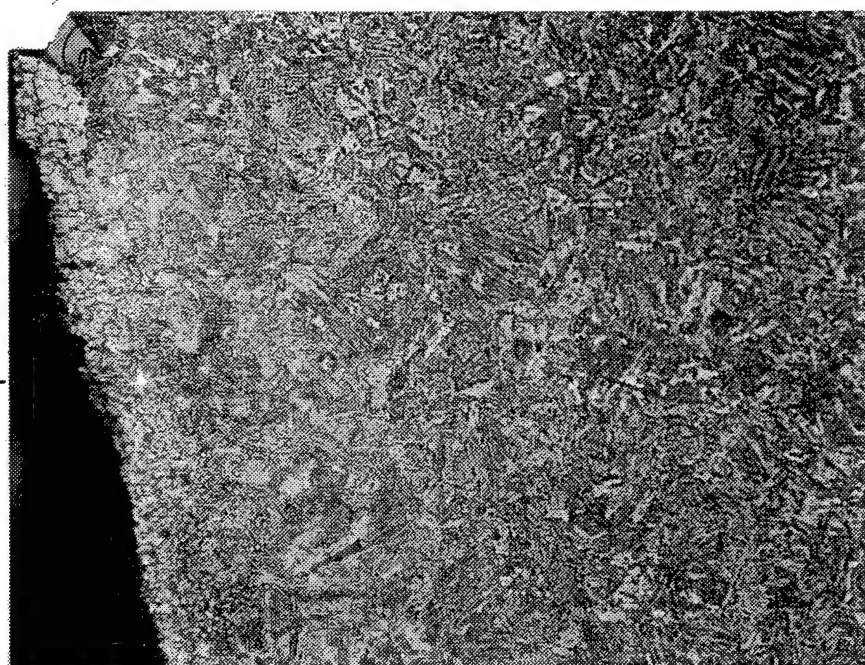
Figure 18. Vickers Microhardness Profile Along the Socket of Setscrew N2. (Note the larger indent within the decarburized layer indicating a softer material; magnification 500x.)
